Proceedings of
UNESCO Chair Programme on
Cultural Heritage and
Risk Management,

**INTERNATIONAL TRAINING
COURSE (ITC) on DISASTER
RISK MANAGEMENT of
CULTURAL HERITAGE
Ritsumeikan University**

2014, 9th year

From 6th to 22nd September 2014,
In Kyoto, Kobe and Minami Sanriku-Cho,
Japan

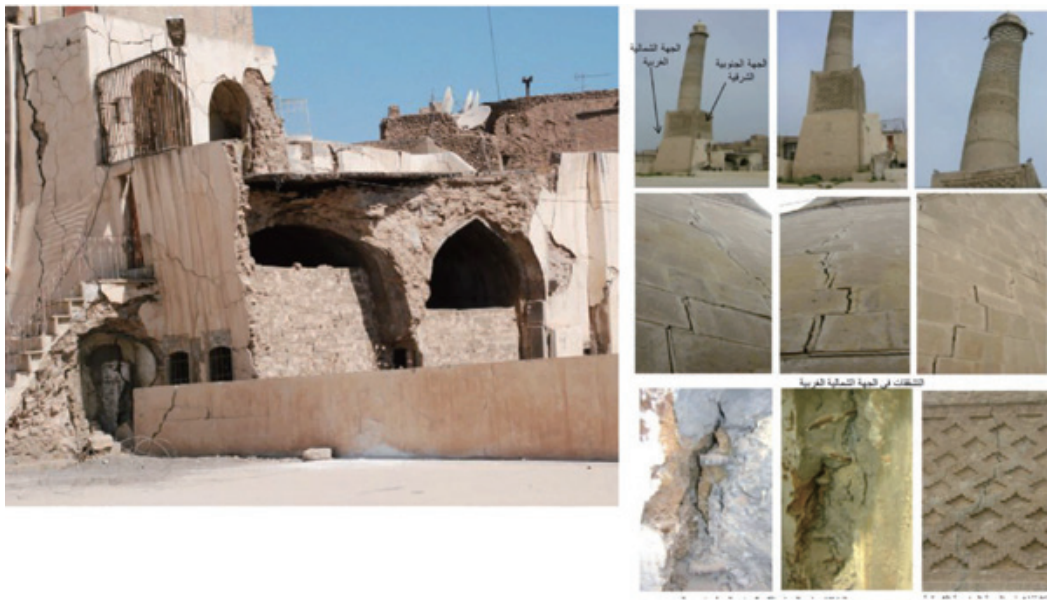
Fig. 5 The cracks in the base and the body of the minaret

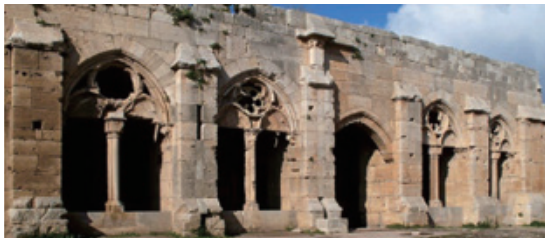
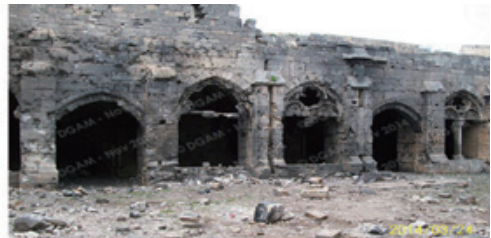
Fig. 4 The front hall of the Knights before and after the terrorist acts ³⁾

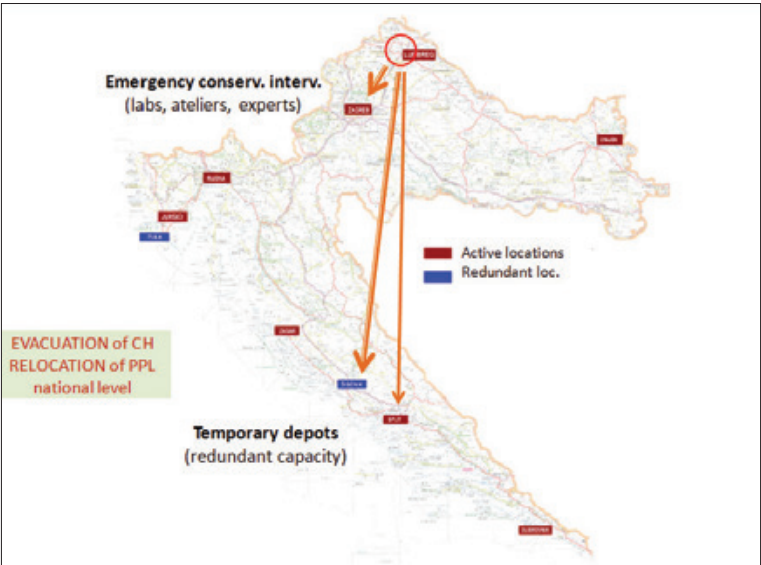
Fig. 8 Possible evacuation routes towards the redundant (receiving) locations of the Croatian Conservation Institute for both employees and cultural heritage, in case a disasters strikes Ludbreg. Image may also be interpreted as the overview of potential restoration support, which could be pooled from the other indicated (unaffected) restoration departments of the Institute
Adapted from source: Annual Report of the Croatian Conservation Institute 2009.

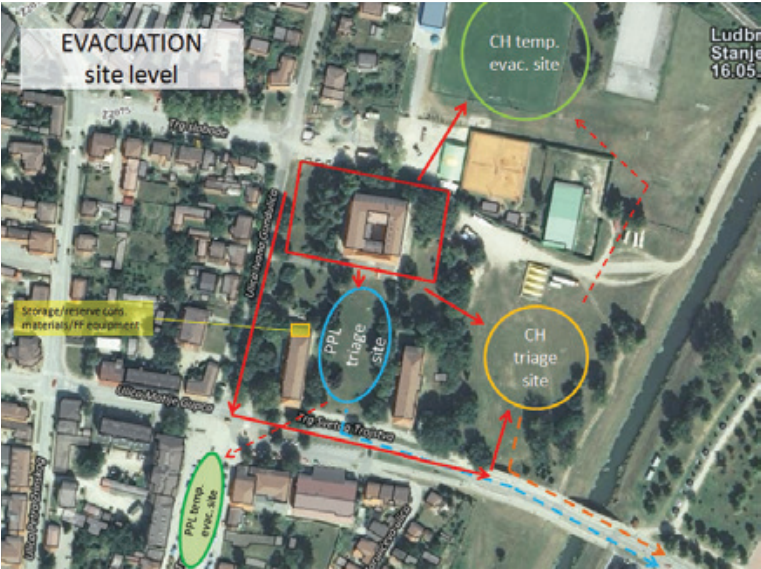
Fig. 9 View of the considered heritage site indicating the usage and organization of the immediate surroundings of the Castle, the auxiliary storage of reserve materials and fire-fighting equipment, as well as with the evacuation routes away from the site

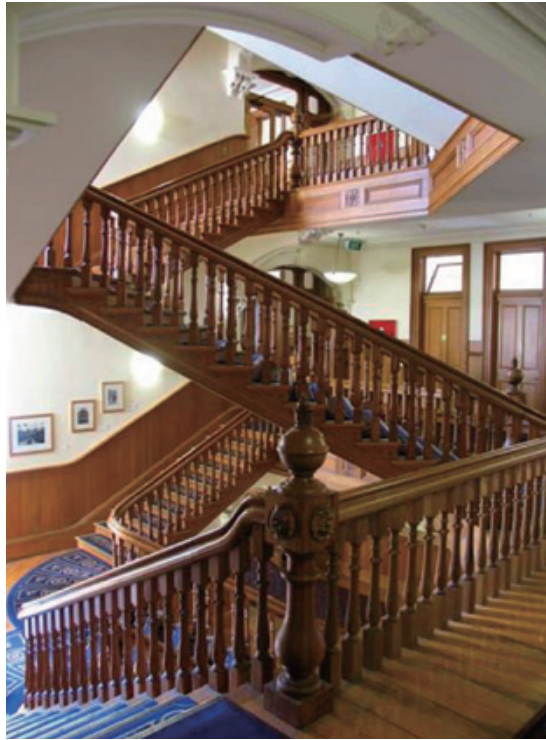
Fig. 2 Hanging Staircase Government Buildings

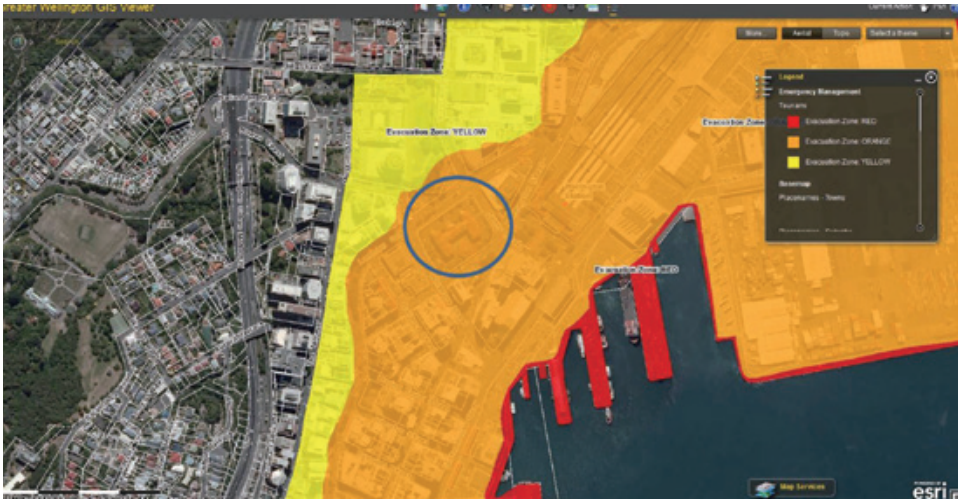
Fig. 5 Tsunami Risk Zones

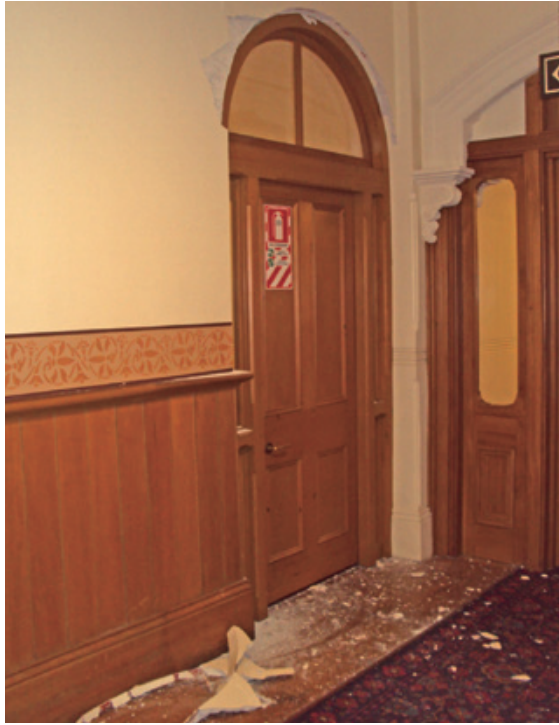
Fig. 6 Earthquake damage 2013

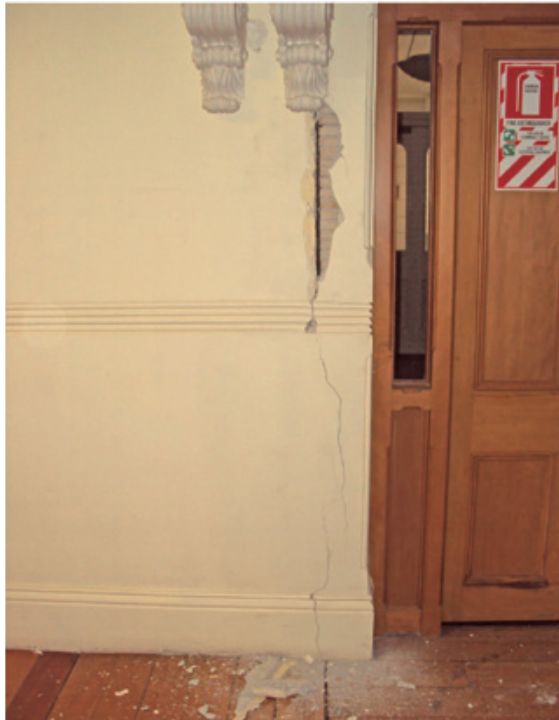
Fig. 7 Plaster damage from Earthquake 2013

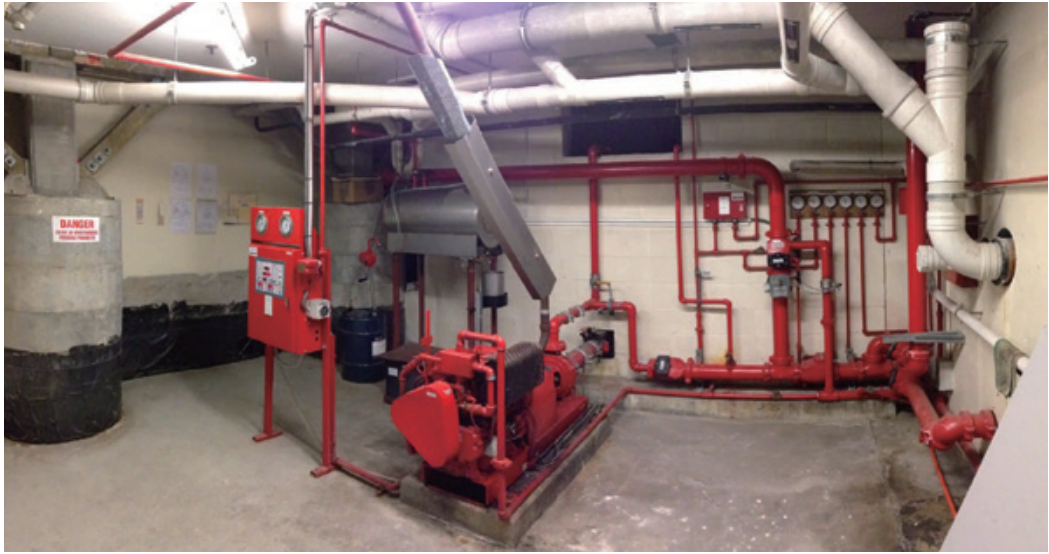
Fig. 8 Government Buildings - Sprinkler Pump and Control room
