Proceedings of
UNESCO Chair Programme on
Cultural Heritage and Risk Management

INTERNATIONAL TRAINING COURSE (ITC) on DISASTER RISK MANAGEMENT of CULTURAL HERITAGE, Ritsumeikan University

2018, 13th year

At Kyoto, Hirafuku and Kobe, Japan

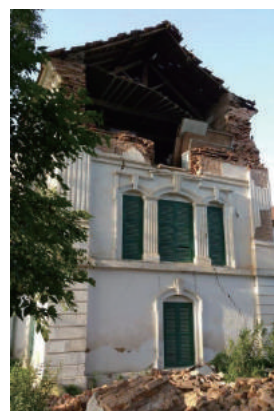
Fig.3 National Museum in Kathmandu, Nepal was heavily damaged due to 2015 earthquakes. Salvage of collections from the damaged buildings was hugely challenging task

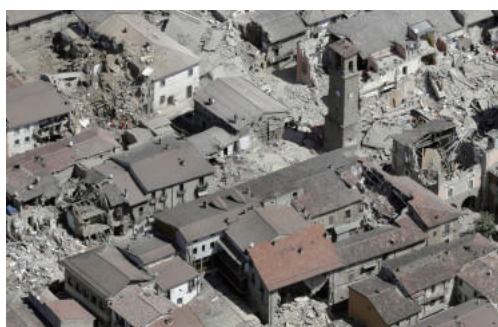
Fig.4 Earthquake struck Central Italy on 26th August, 2016 causing extensive damage to historic settlements in the region

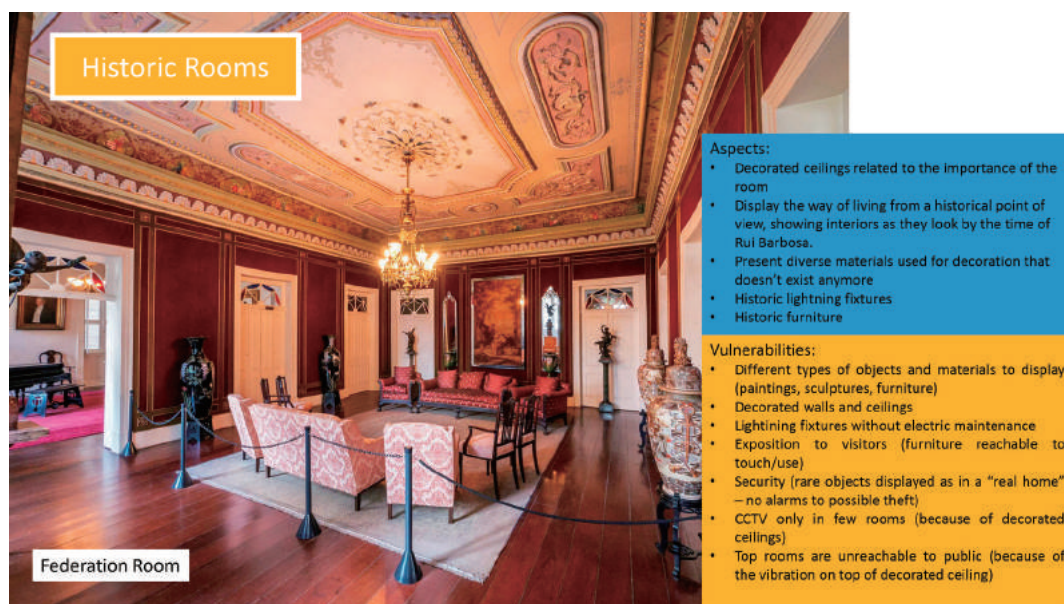
Fig.2 Presentation slide of one of the seven attributes assessed to the House of Rui Barbosa Foundation, presenting main aspects and related vulnerabilities to Historic Rooms.

Cultural Heritage is composed of a group of attributes that contribute towards authenticity, integrity and particular narratives, within a given context. Only with a complete evaluation of the valuable attributes of the HRBF it would be possible to draw a full value assessment, leading to a complete DRM plan. Initially, seven major attributes were chosen to start the assessment: the historic building, historic rooms, historic library rooms, the archival collection, the bibliographic collection, the archive of Brazilian literature and the historic garden. For each of them, different aspects and values were assigned, such as historical, artistic or social values and such as form, function, materials as major aspects. Along with those different aspects and values, each attribute was also evaluated for its inherent vulnerabilities. A description was made for each of these seven attributes, as represented in Fig. 2:

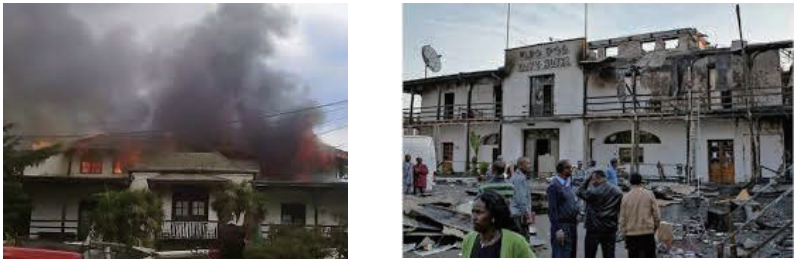
Fig. 2 The Hotel during and after the fire accident in January 11/ 2014

The historic structure has undergone on various changes and challenges that has shaped and influenced to maintain its original semblance and to remain as the city fabric. One of the major challenges the Hotel ever encountered was in January 11/ 2014, when a fire accident partially destroyed its structure. The fire was originated from inside the building and has damaged many of the hotel’s rooms, its historic pieces & artifacts and wooden structures before it was put under control. Many of the hotel’s rooms, its historic pieces and a bank office were completely burned down before firefighters put out the fire. The City’s Police Commission disclosed that the cause of the fire accident that devastated the historic Taitu Hotel was a faulty of electric wiring.

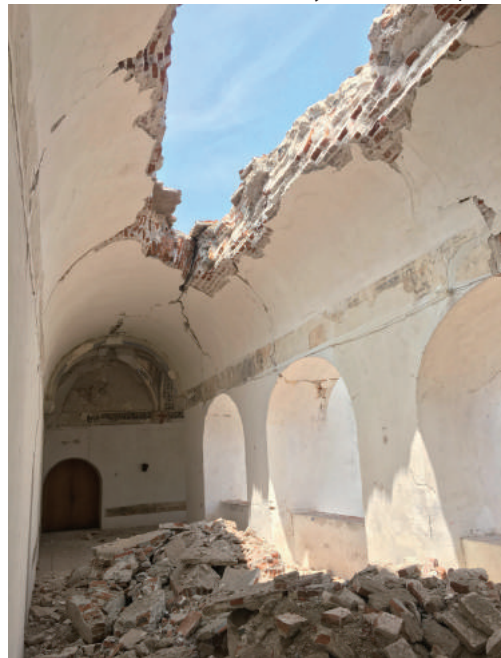
Fig.1 The Dominican Convent of Tehuantepec after the September 7th M8.2 earthquake. Photograph: David Torres

The first event, having the epicenter around 180 km from Santo Domingo Tehuantepec, the precise location of the Convent, had an enormous impact on the building, damaging the historic structure, the architectonic finishes and decorations, and somehow affected almost all the cultural objects and collections kept inside. During the emergency fase, some quick measures where taken to rescue and stabilize the cultural assets and attributes of the site, and protect them from further damage. Veils where applied to damaged wall paintings using non-woven materials, all the collections where stored, evacuated and secured to the undamaged area of the building with restricted access. This was the situation for the Dominican Convent before 2018 ITC and the reason it was selected as case study for the course.

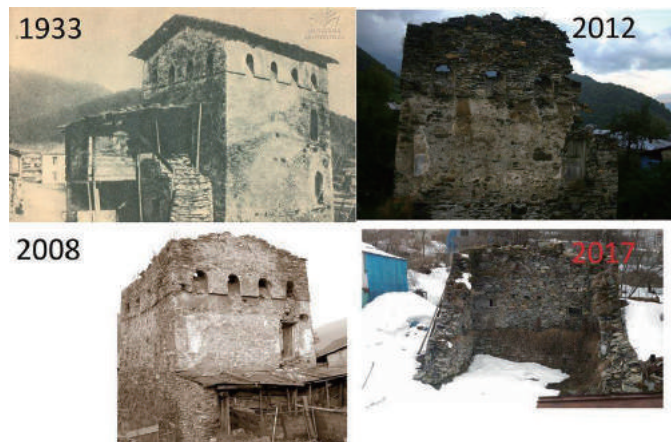
Fig.4 Ushguli Community - Collapsed buildings

Geomorphologically, area of Ushguli community is dominated by fluvio-glacial landforms where glaciers have developed U-shaped valleys with steep slopes. In the higher parts of these valleys (above 3000 m.a.s.l.) and close to the still glaciated areas periglacial processes such as solifluction occur. On the valley slopes at lower altitude surficial landslides and debris flows are very common. On very steep, near to vertical slopes rock fall frequently occurs. The higher

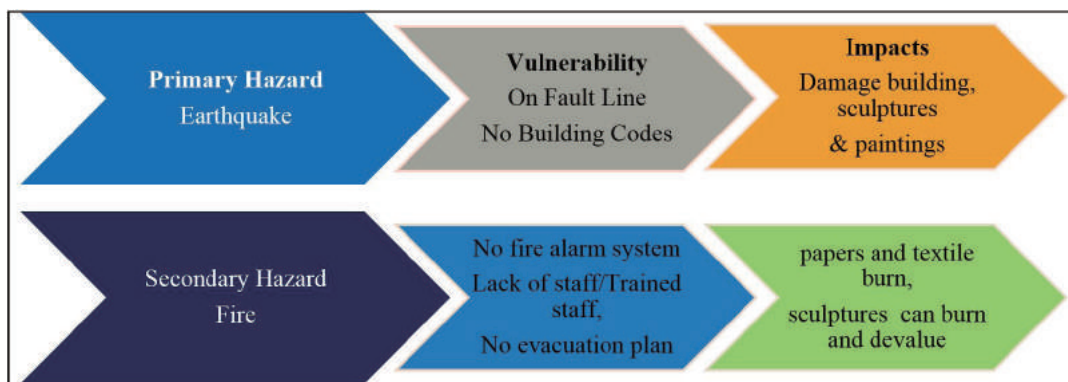
Fig.4 Risk Assessment Process of Peshawar Museum,

Geographically the province of Khyber Pakhtunkhwa (KP) is mostly mountainous having a rich history of earthquakes. After conducting the risk assessment process earthquake was identified as a primary hazard and fire as a secondary hazard see Fig 4.

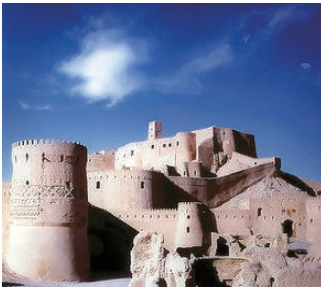
Fig.1 Arg-e-Bam before earthquake

According to the report of United Nations Organization, Iran is amongst 10 countries which is most exposed to natural hazards. Arg-e-Bam, which was a unique cultural heritage; totally collapsed due to the great Bam Earthquake of 2003 that struck the Kerman province. Arg-e-Bam is famous as the largest structure in the world made out of masonry and dated back to 5 century B.C.

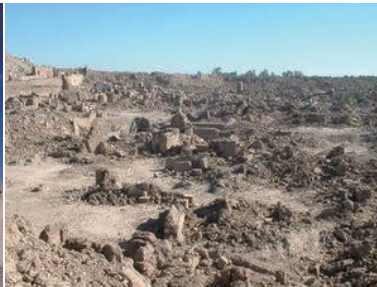
Fig.2 Arg-e-Bam after happening of earthquake

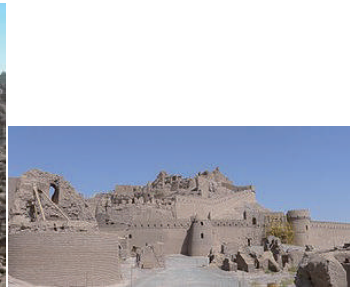
Fig.3 Arg-e-Bam nowadays after reconstruction

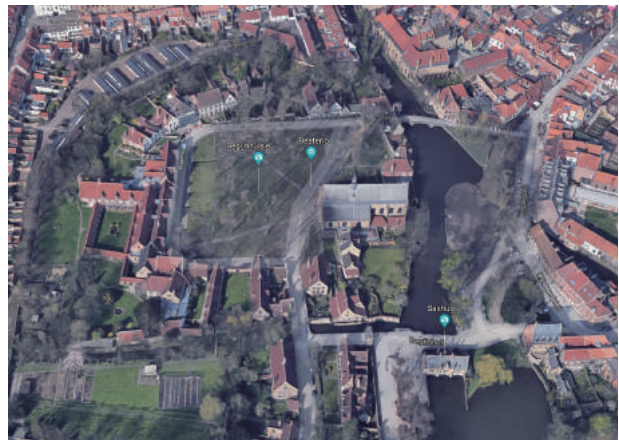
Fig.2 The Béguinage of Bruges seen from above © Google Maps

The OUV's tell more on the most important heritage and monuments of the city. Based on this, further assessments can be made. The Béguinage of Bruges was selected as one of the attributes for this case study. The values of this Béguinage are in the typical character of the form and design which is a huge pull factor for visitors and its users. It creates a center of peace in the city and is one of the greenest places near the waterside. The preservation of its characteristics and lasting inhabitation by women keeps the tradition and purposes of this site in stand.

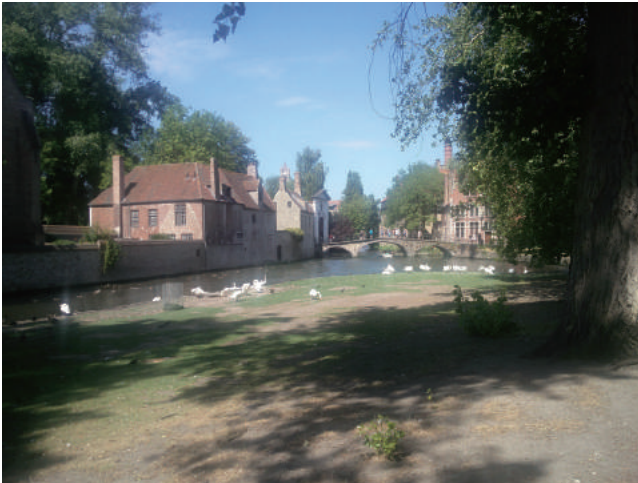
Fig.4 View on the canals of Bruges near the Béguinage © Grace DS

As these flooding by heavy rains and storms can become more and more likely to happen, it could also bring severe damages to the heritage located near the little canals including some of the museums. This primary hazard can cause secondary hazards such as blockages or fires. A map of the flood risk zones (Fig. 3) shows the most prominent areas are located near the ring road in the south of the city and the most important hospital in the North-West. As an outcome of this analysis an evacuation plan could be made in collaboration with the

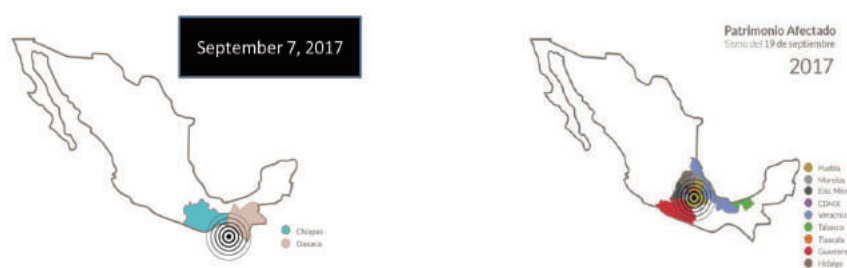
Fig. 1a and 1b Affected area of Mexico earthquakes, 2017. Source: CNCPC-INAH.

On September 7th, 2017, an earthquake struck the southern part of Mexico; 12 days later another earthquake struck central part of the country. Apart from the important human and infrastructure damages, the immovable and movable heritage was also damaged. Several historic temples lost domes and vaults, while its sculptures, bells, altars, among others were badly damaged.

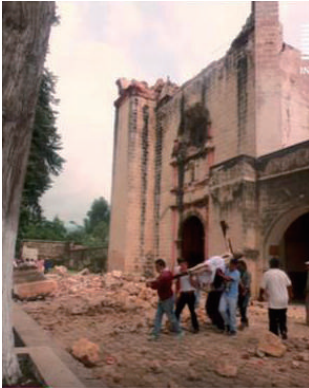
Fig. 8 and 9 First aid carried by local people at the Temple of Totolapan, Morelos.

during these emergency actions as there were so many places to go and not enough personnel. Many volunteers, professionals and students offered to help but unfortunately they had to be rejected as they had no received previous training and the emergency plan was not clear. Therefore, during the following days INAH personnel focused on taking care of the emergency actions for the more recognized immovable and movable heritage, or where the damage had been so severe that special attention was required. Little by little, the national agency started to attend the rest of the damaged heritage and insisted on one workflow where first structural stabilization was done to the temples and then salvage for the movable heritage took place, including moving the objects to a safe storage, protecting immovable and movable heritage from rain and weathering, and removing damaged heritage from the debris. The religious structures were closed waiting for a structural evaluation and therefore preventing any further collapse that could hurt anybody. Temporary structural supports were installed between architects, engineers and the local people. Sadly, the closing of religious structures temporarily interrupted the local traditional practices. Therefore, people became depressed about the situation. However, this made the communities resilient and many decided to continue with their traditional practices outside the church, which finally highlighted the importance of the intangible heritage for a community.

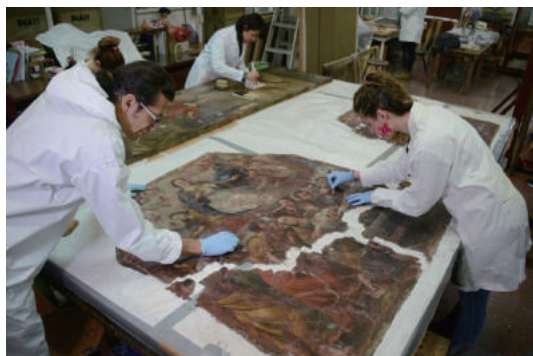
Fig. 14 Restoration of damaged paintings from the Temple of Ocuilán, Estado de México. Source: CNCPC-INAH.

Currently we are in the recovery stage; 293 historic religious buildings have already been restored while several sculptures, paintings, bells, murals and altar pieces are being treated for its conservation. However, we have noticed that the budget spent up to now has mainly been designated for the immovable
