Proceedings of
UNESCO Chair Programme on
Cultural Heritage and Risk Management

INTERNATIONAL TRAINING COURSE (ITC) on DISASTER RISK MANAGEMENT of CULTURAL HERITAGE, Ritsumeikan University

2019, 14th year
From 9th September to 30th September 2019
At Kyoto and Hyogo, Japan

Organized by Institute of Disaster Mitigation for Urban Cultural
Heritage, Ritsumeikan University (R-DMUCH), Kyoto, Japan

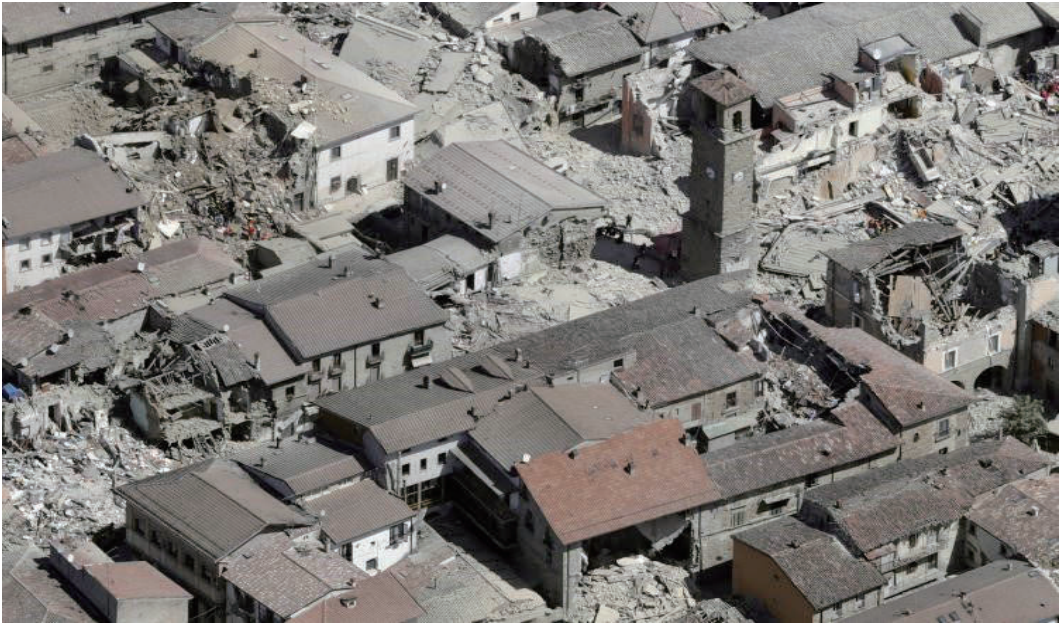
Earthquake struck Central Italy on 26th August, 2016 causing extensive damage to historic settlements in the region

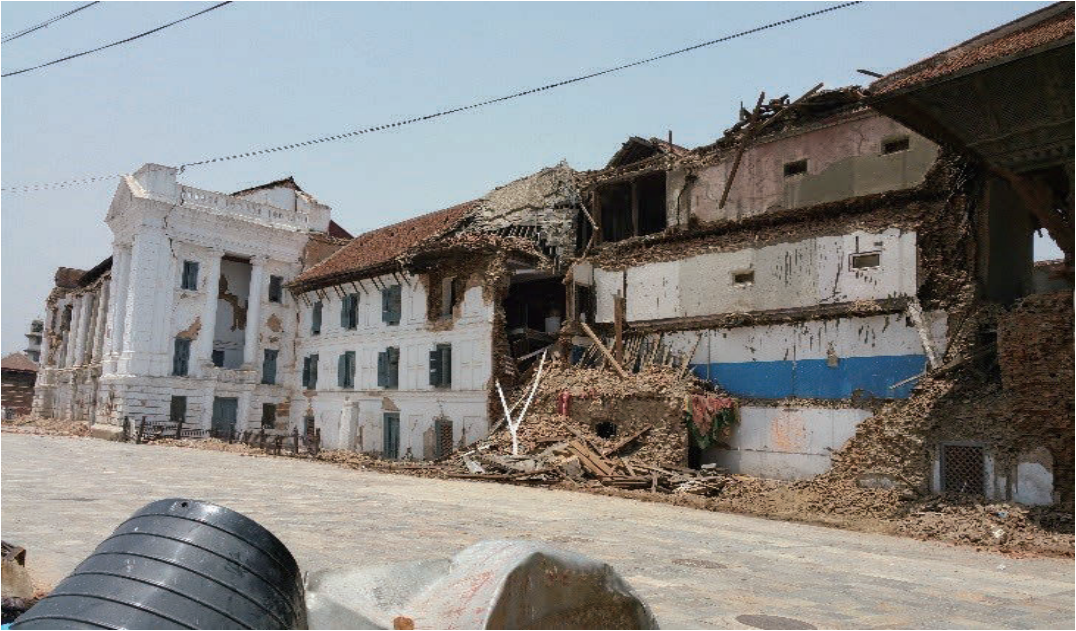
The buildings related to Hanuman Dhoka Palace Museum damaged in the 2015 earthquake, Kathmandu, Nepal

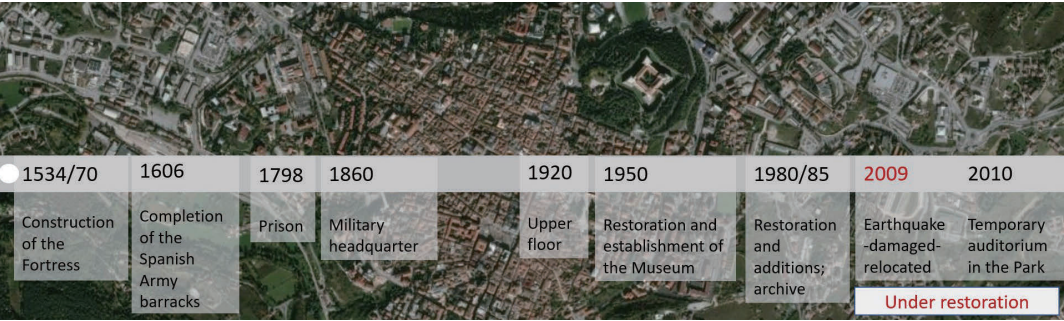
Figure0. timeline of the relevant construction works on the Spanish Fortress between 1534 and 2009 (source: author elaboration on Google image and MuNDA)

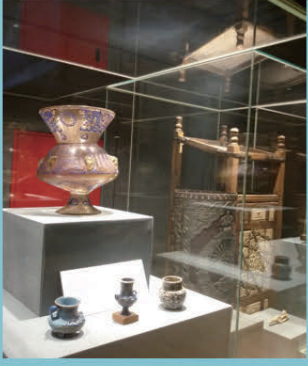
Figure 5 a table shows earthquake hazard, vulnerabilities, and effects and impacts.

Hazard	Vulnerability	Effects and impacts
Earthquakes	<ul style="list-style-type: none">- Location <u>near from</u> the earthquake center at <u>Helwan Area</u>- Geological area layers cracked and fractured <u>lime stone</u>.- No considerations in museum buildings design for occurring Earthquakes .- Bad display practice (No consideration for glass material objects)	<ul style="list-style-type: none">■ partial damage■ fractured■distortion■ loss for values

- a- The earthquake : The location of the museum is 20 km from the earthquake center in Helwan area. So, if the museum is exposed to earthquake vibrations, they could cause fire, damage to its buildings built of concrete and glass. (figure.4). Then, we might experience a loss of life (whether museum staff or museum guests), artifacts, and some of its artifacts values.
- b- Fires: fires are due to many reasons such as an earthquake hazard, arson, human threats, human bad behavior, or ignition materials (figure.5).
- c- Heavy rain water can cause damage to the museum's buildings and artifacts existing in basement storerooms because there are technical defects in the design of the museum as the ground level of museum is lower than the street. Therefore the museum is exposed to

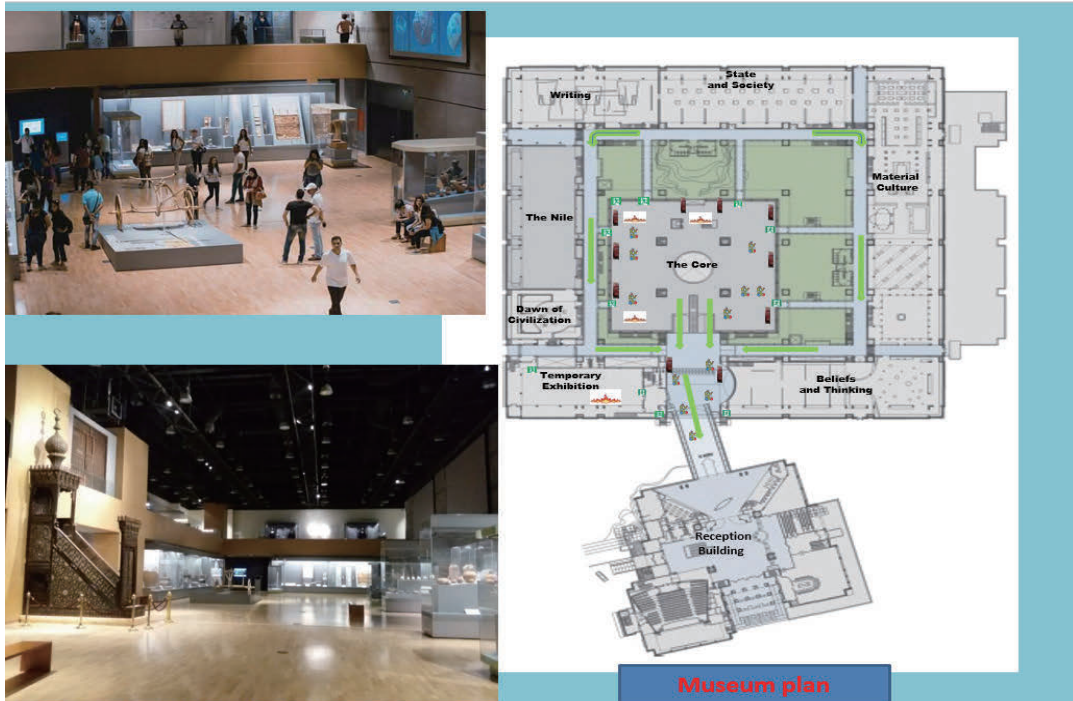
Figure 8 photos and plans of exhibition galleries show an evacuation plan proposed

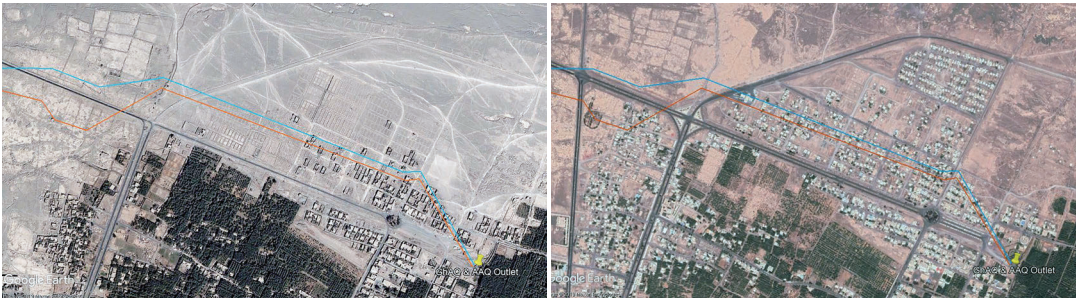
Figure 2 The course of QAQ (blue line) and AAQ (orange line) in 2004 (left) and 2019 (right), showing construction sprawl within the Qanats' buffer zone through time.

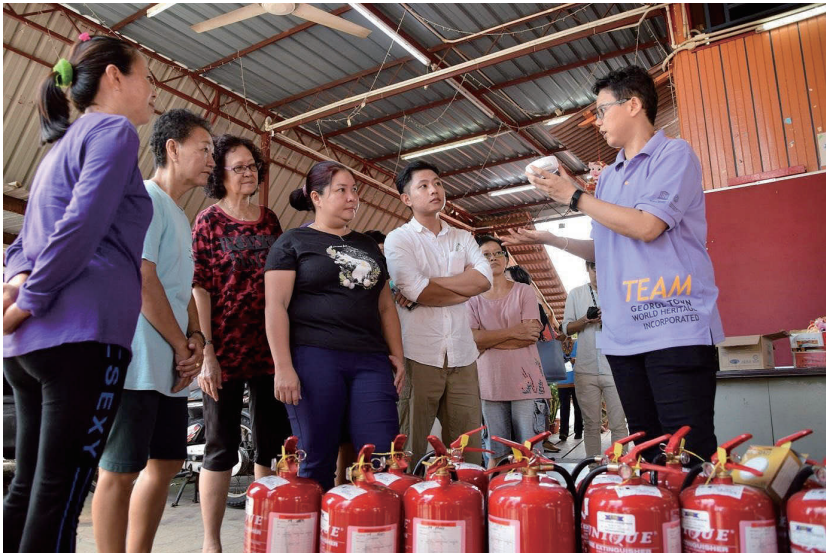
Figure 17: GTWHI representative explaining the operation of fire extinguishers to the residents of Lim Jetty.

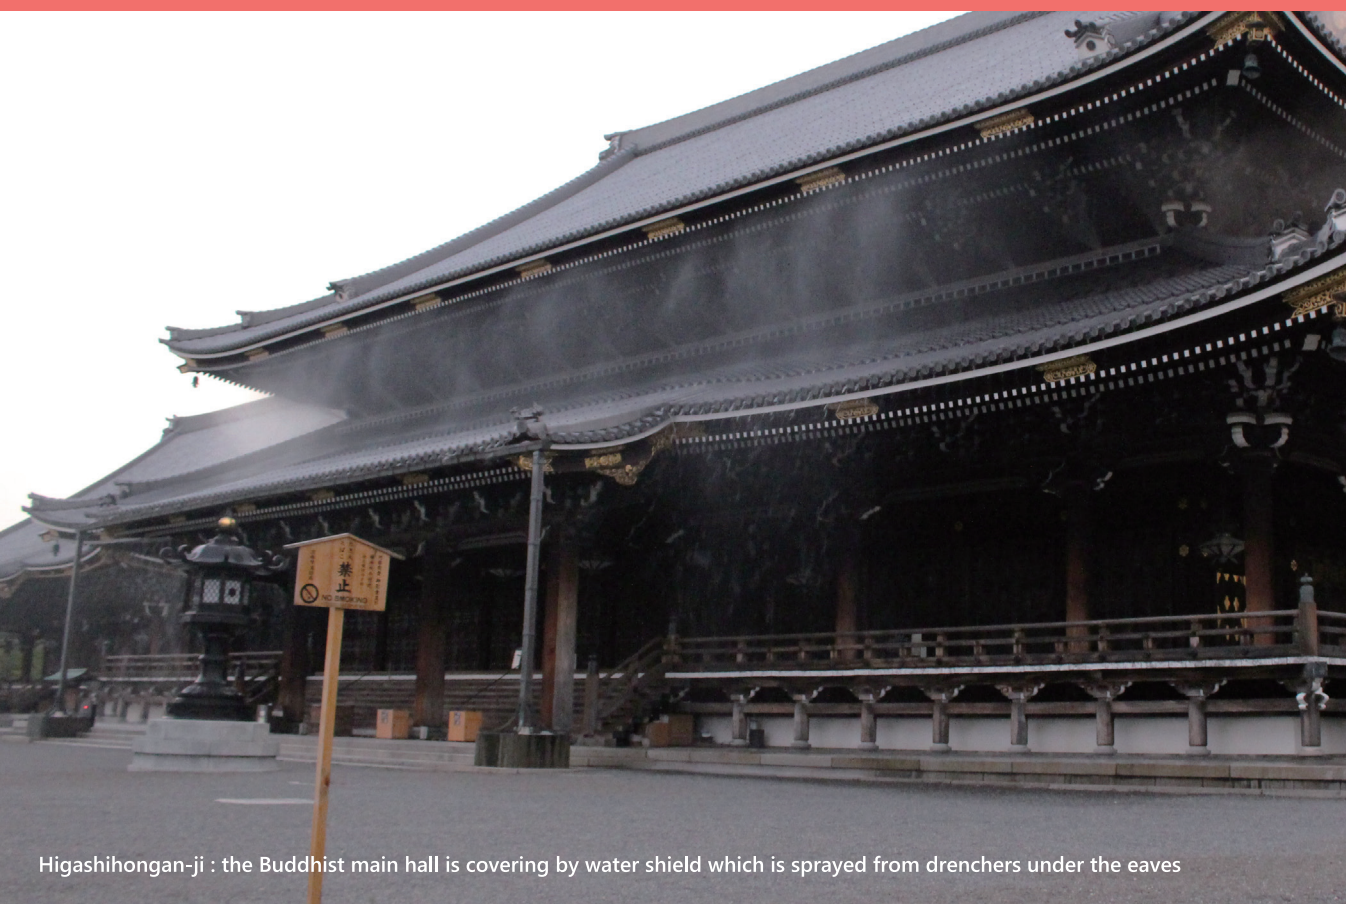
Higashihongan-ji : the Buddhist main hall is covering by water shield which is sprayed from drenchers under the eaves
